ENGINEERING ANALYSIS

RUSSIAN T34/85 TANK

SEPTEMBER, 1951

CIA Information Report Number 00-T-00061 THIS DOCUMENT CONTAINS INFORMATION AFFECTING THE NATIONAL DEFENSE OF THE UNITED STATES WITHIN THE MEANING OF THE ESPIONAGE LAWS, TITLE 18, U.S.C., SECTIONS 793 AND 794. THE TRANSMISSION OR THE REVELATION OF ITS CONTENTS IN ANY MANNER TO ANY UNAUTHORIZED PERSON IS PROHIBITED BY LAW.

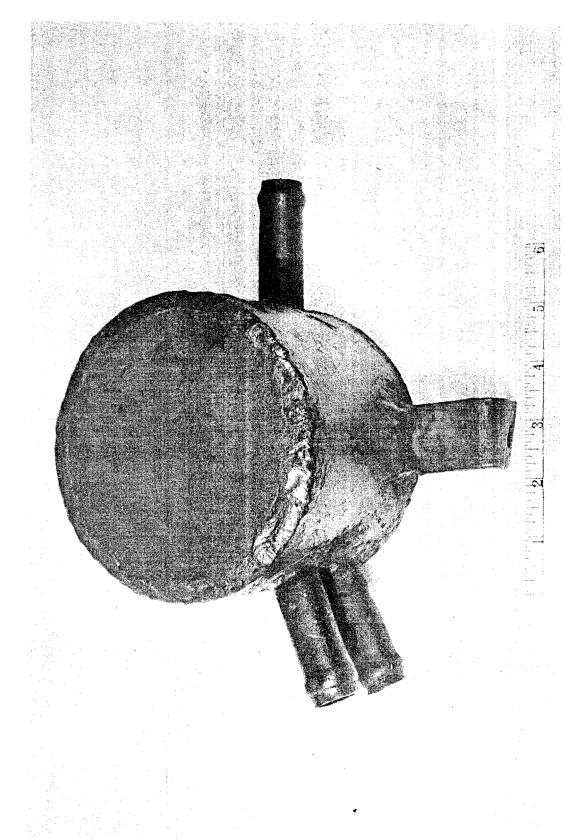
HOLLOW CHAMBER IN LUBRICATING OIL LINE BETWEEN RADIATOR AND OIL TANKS

The vessel was welded all over, with no means provided for access to the contents. One possible use of the chamber is to trap water vapor. The chamber was found in a high point in lines joining the oil radiator and the two oil storage tanks. Water vapor rising into the chamber would condense and drop to the bottom where, if it froze, no harm would be done. Later operation of the tank, with consequent rise of the oil temperature to and above the water boiling point, would automatically dispose of the entrapped water.

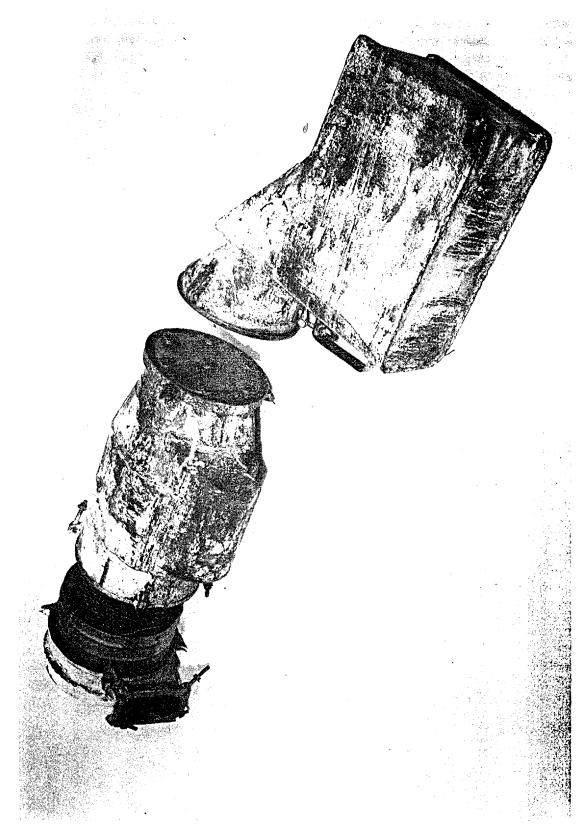
304 - INTAKE AIR CLEAN

To service the air cleaners, at least one transverse louver would have to be removed from the top of the hull. This required removal of four bolts from one of the end plates which provided sockets for the louver trunnions. Because of the poor accessibility of the air cleaners, it is unlikely that they were serviced very often. The cleaners were of such low efficiency and low dirt capacity that, in dusty operation, they should have been cleaned at least once each day and preferably several times if any appreciable engine protection were to be obtained.

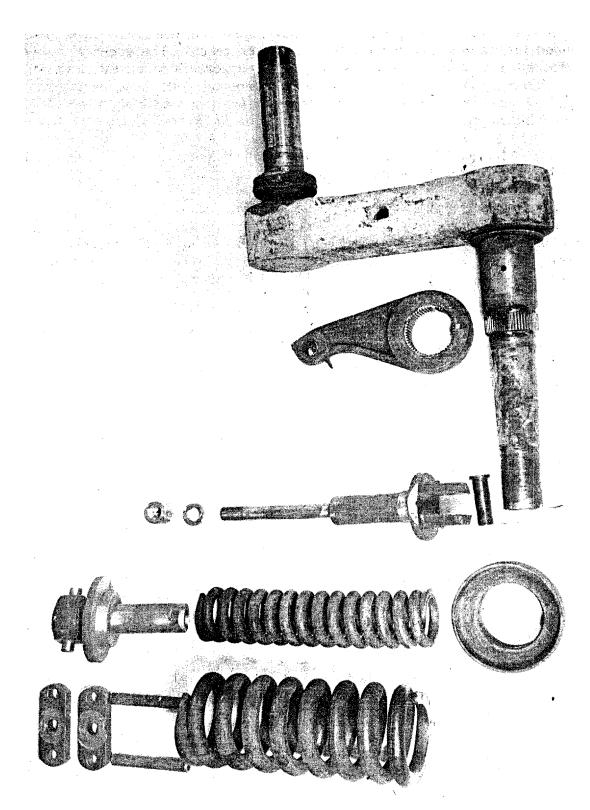
1301.0 - FRONT SUSPENSION ASSEMBLY

Yet a failure to machine sufficient clearance at the clevis root of the front suspension spring arms had not been caught by inspection. As the result, both front suspension spring guide rods had been bent and had worn severely. The sticking of these bent rods in their bushings could have caused loss of track tension and consequently loss of track. It is not known whether the track had actually been lost before the tank was captured.

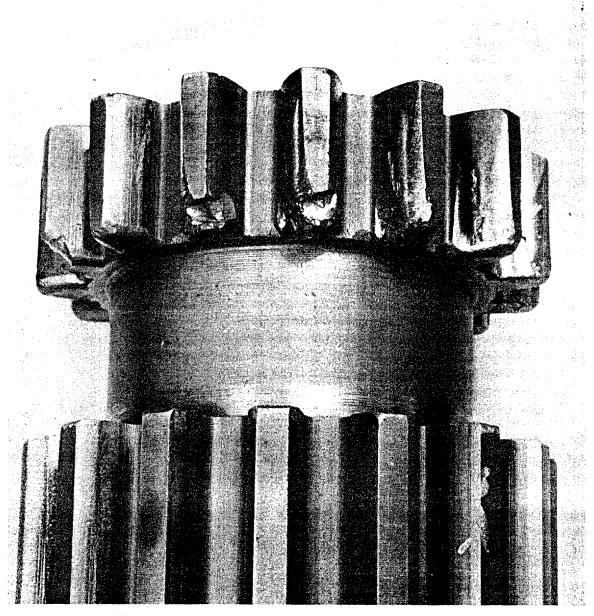
0702.5.6 a - REVERSE IDLER GEAR CLUSTER

The reverse idler was upset to form two gears in a cluster so that the flow lines were bent to form the tooth section of each gear. It was machined all over, carburized and hardened. The gear was shot blasted and the finish grind operations performed. The finish ground bore of the gear, which acts as a bearing seat, was file hard. The chamfered edge of the 15 tooth gear is battered and worn and chipped. The base of the tooth has a heavy groove worn on a taper starting at the edge of the tooth. The 16 tooth gear has grooves worn the full length of the tooth at the base. Photograph 0702.5.6 a

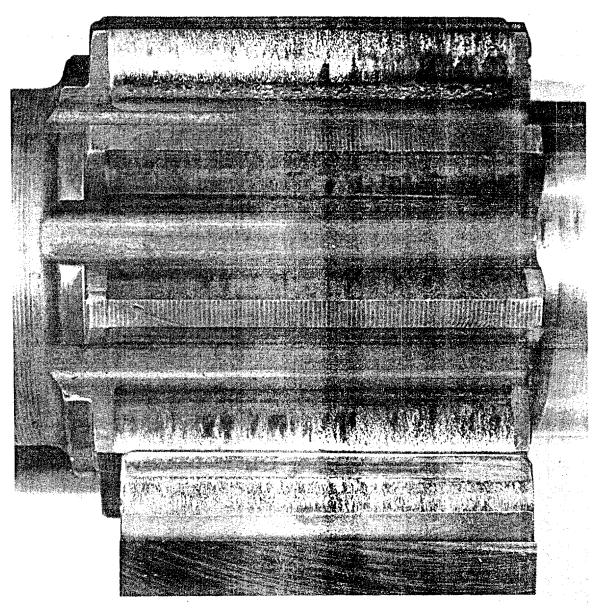
1008.4 - FINAL DRIVE PINION AND BULL GEAR SECTION

The final drive pinion was forged from Krupp steel in such a manner that the flow lines show the stock bent to form the tooth section. The analysis is shown in Table VIII. The pinion was machined, carburized all over and hardened. It was then shot blasted and the finish grinding operations performed. The teeth were worn and pitting had occurred at the bottom of the tooth face. Photograph 1008.4

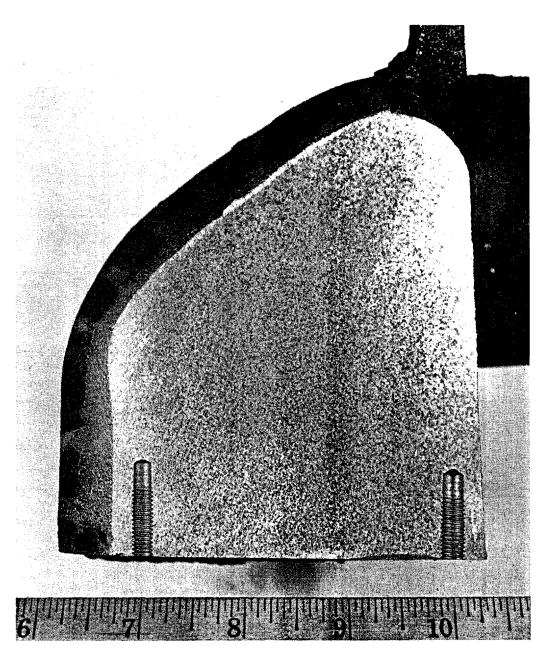
6417 - MACRO SECTION OF AIR CLEANER-TO-INTAKE MANIFOLD ELBOW

D. Manufacturing Method & Quality Sand casting - Poor quality. B.H.N. values indicate as-cast condition.
MICROSTRUCTURE: Aluminum copper and acicular aluminum silicide uni- formly dispersed in matrix.
